**HARTZELL PROPELLER LLC**

**HC-SL-61-376**

## **Tool Modification and Alternate Propeller Mounting Hardware**

May 13, 2026

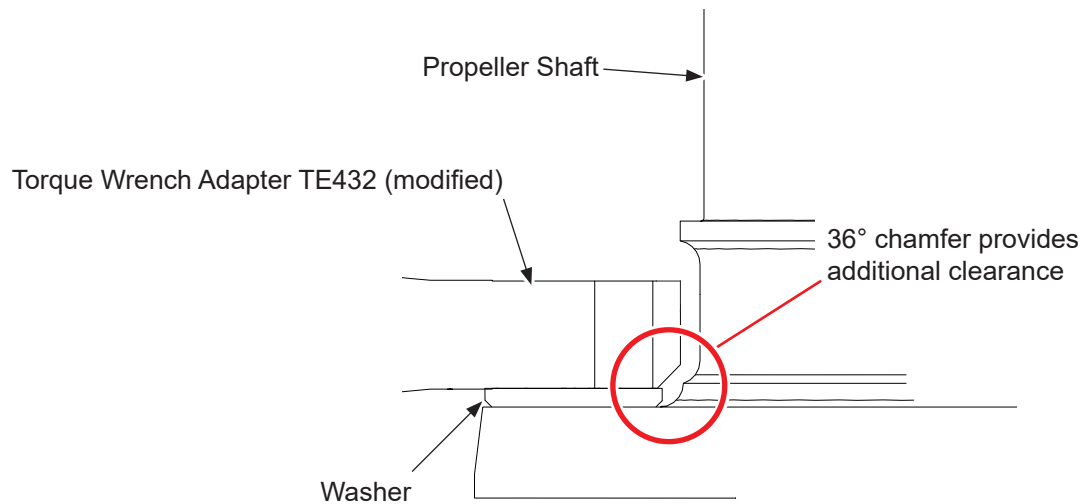
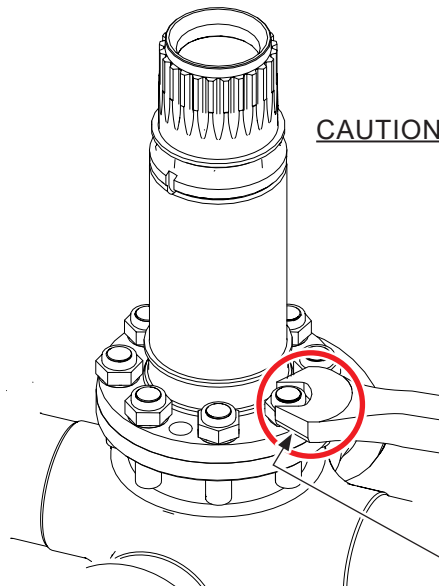
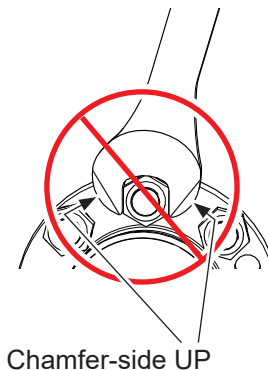
**Modified Torque Wrench Adapter  
Figure 1**

- (1) Hartzell Propeller has received reports about damage to the propeller shaft when using the torque wrench adapter TE432 for installation and/or removal of affected propellers.
  - (a) Additionally, GE Aviation Czech s.r.o. Service Bulletin SB-000447 and Thrush Aircraft Service Bulletin SB-AG-82 were issued to address propeller shaft damage during installation and/or removal of affected propellers on the aircraft.

**CAUTION 1:** DO NOT LET THE TORQUE WRENCH ADAPTER CONTACT THE ADJACENT NUTS OR THE PROPELLER SHAFT FLANGE RADIUS WHEN LOOSENING OR TIGHTENING THE MOUNTING NUTS.

**CAUTION 2:** ALWAYS USE THE MODIFIED TORQUE WRENCH ADAPTER WITH THE CHAMFER-SIDE DOWN.

- (1) This Service Letter provides Additional Maintenance Information (AMI).
- (2) This Service Letter provides instructions for a modification of the torque wrench adapter TE432 that reduces the dimensional profile of the tool.
  - (a) The modified torque wrench adapter TE432 provides more clearance to reduce the risk of damage to the propeller shaft flange radius when installing/removing affected propellers. Refer to Figure 1.
- (3) This Service Letter introduces washer (p/n: 109514) as an alternate for washer (p/n: B-7624) used on the affected propellers.
  - (a) The washer (p/n: 109514) is a thicker than washer (p/n: B-7624). The thicker washer provides additional clearance for the torque wrench adapter TE432.
